Intel[®] Pentium[®] II Processor Specification Update

Release Date: May 2000

Order Number: 243337-036

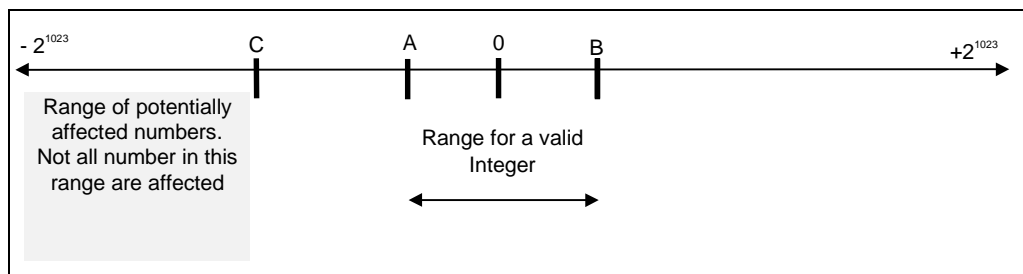
Problem: On certain, large, negative, floating-point operands, and only in three of the four possible processor rounding modes, the instructions FIST[P] m16int and FIST[P] m32int do not detect that the operand is so large that it will not fit into the target data size. As a consequence, the expected Invalid Operation exception response for this situation is not correctly provided, nor is the Invalid Operation flag set in the Floating-Point status word as specified in the *Intel Architecture Software Developer's Manual, Volume 2: Instruction Set Reference*. Under the failing conditions, noted below, the precision exception (#PE) flag will also be incorrectly set.

Implication: Erroneous operation results when the operand is so large that it will not fit into the target data size. The operands affected by this erratum are significantly outside (by a factor of 3X) the range that can be, correctly, converted to an integer value. The figure below and corresponding table identifies the normal range of integer numbers (between A and B) and the starting point of the operands affected by this erratum. Discrete failing operands will be present in the range between point C and the maximum negative number that can be represented by the processor (-2^{1023} in double precision format). Note 2 below gives a qualitative description of the nature of the discrete failing values. Software that does not rely on the Invalid Operation exception flag being set and signaled by either an exception OR by software polling is not impacted by this erratum.

16-bit Operation	A	B	C
	-32,768.0	+32,767.0	< -98304.0
32-bit Operation	A	B	C
	-2,147,483,648.0	+2,147,483,647.0	< -6,442,450,944.0

Workaround: Any of two software workarounds will avoid occurrence of this erratum:

1. Range checking performed prior to execution of the FIST[P] instruction will prevent the overflow condition from occurring, and may already be implemented as a coding style.
2. Software can use the presence of MAXNEG in the result integer to indicate that an out of range conversion may have occurred.
